Pre Purchase Building Inspection Report

ADDRESS. Sample Report

This Pre Purchase Property Inspection report is carried out in accordance with and complies with Australian Standard AS 4349.1-2007. Standard Property Report Section 3.

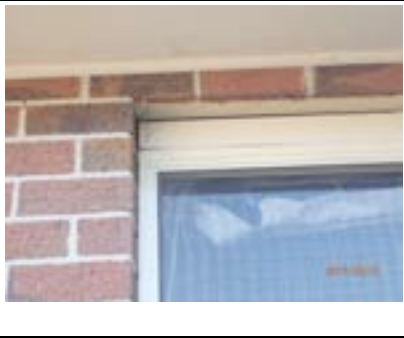
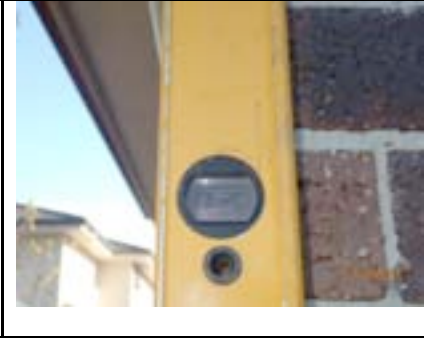
Doors / Windows:

<p>Comments: See east facing window above with minor gap from brickwork movement away.</p> <p>Note level still well within guidelines.</p>		
SUBFLOOR:

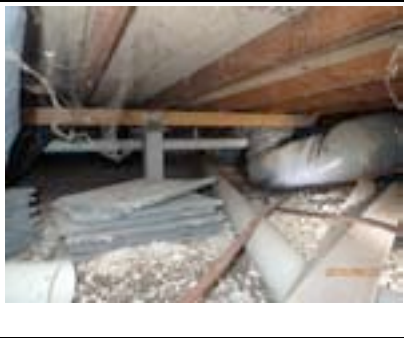
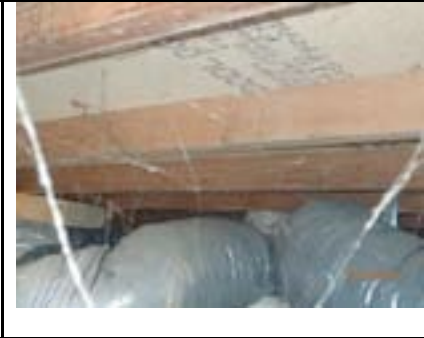
<p>Comments: Hardwood bearers and joist all looks dry, no sign of moisture or movement, no defects.</p>		
PORCH / PAVING:

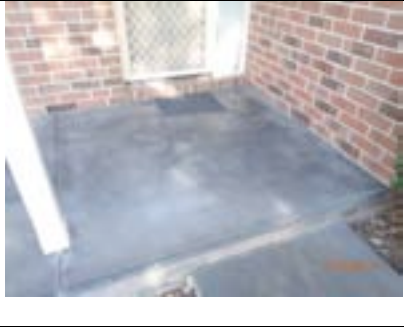
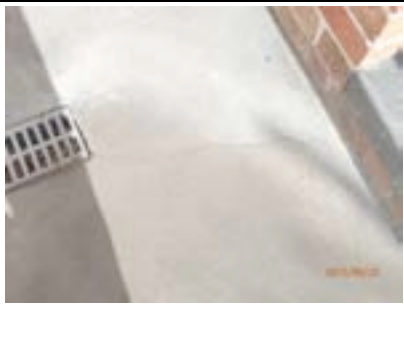
PORCH / PAVING:

Garage	G	
Paved areas	G	Concrete pave areas to front. Minor cracking to front driveway, no defect to be expected due to settling over time.
Drainage	G	Strip drain in front of garage in good condition .

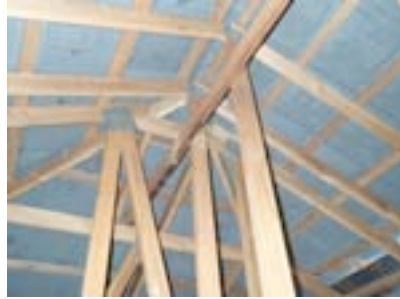
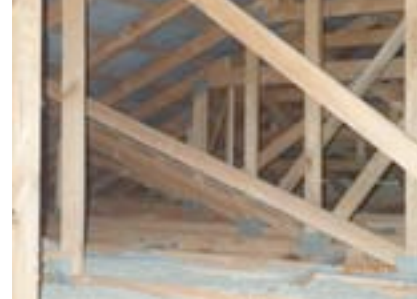
ROOFSPACE:

Comments: In good dry condition.

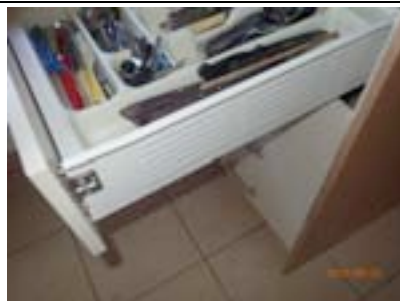
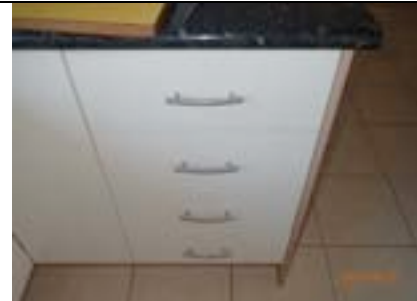
FITTINGS:

Comments:		
PLUMBING/ ELEC: :	 	 
	Comments:	
SHOWERBASE/ DOORS:	 	 
	Comments: In good condition, no defects.
